RETRIEVAL ANALYSIS OF CERAMIC ON POLYETHYLENE TOTAL HIP REPLACEMENT

ABSTRACT

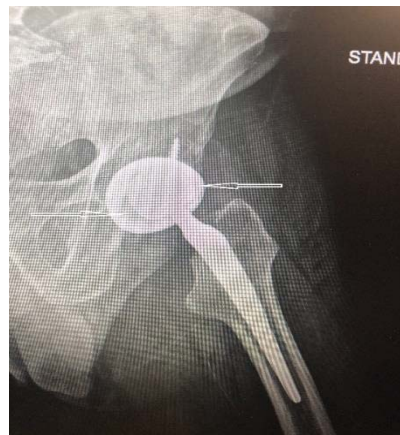
Approximately 6 weeks following the surgery, the patient presented to the surgeon's office complaining of squeaking in the left hip. An anteroposterior imaging showed subluxation of the implant (Figure 1). A CT scan was ordered to supplement the radiographic images and showed asymmetric seating of the femoral head component within the acetabular cup. There was no periprosthetic fracture or evidence for osteolysis at that time, nor was there any aseptic loosening of the implant. Revision was discussed with the patient and subsequently performed.

Figure 1: AP lateral image showing partial dislocation of the femoral head.

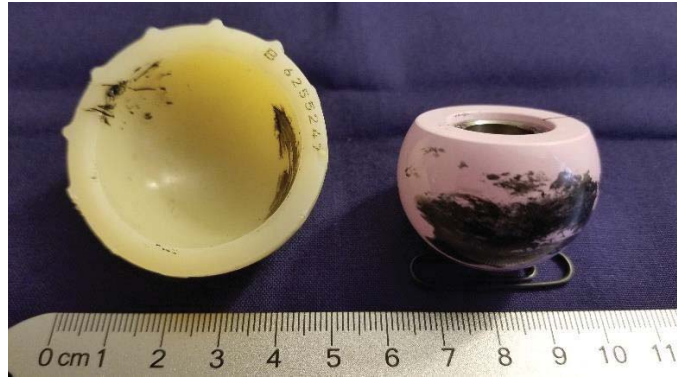
Analysis of the original (pre revision) liner and femoral head, found the ceramic head and polyethylene liner to both have scratches and abnormal wear. Post-operative review of the implant showed no signs of malpositioning of the femoral stem. The acetabular liner had shallow as well as deep scratches of varying lengths, with the longest being approximately 2.0cm in length (Figure 2). Scanning electron microscope photos show aberrant scrapes and wear at the microscopic level (Figure 3). The ceramic head did not seat evenly when placed into the liner, with uneven spacing on adjacent sides. On some sides the ceramic head was touching the polyethylene liner with no visible space between them, while on other sides there was an approximate 0.10cm gap between the head and liner (Figure 4). The liner was found to have an inner diameter measurement of 37mm when measured top to bottom and 36mm when measured side-to-side. Wall thickness was measured at 5.4mm at one side and 4.5mm at the opposite side (Figure 5).

Figure 2: The acetabular liner (left) with deep and shallow scoring, with the longest on the lower right with a length of approximately 2.0cm. The ceramic head (right) showing broad amounts of wear as well.

The scratches and other physical wear to the polyethylene liner and ceramic head can occur from the patient walking on a partially dislocated hip. No bone cement was used during surgery and no foreign object was found during removal, which would support this. The dimensional differences in the acetabular liner and reduced free rotation of the ceramic head may have contributed to the subluxation (Figure 2),

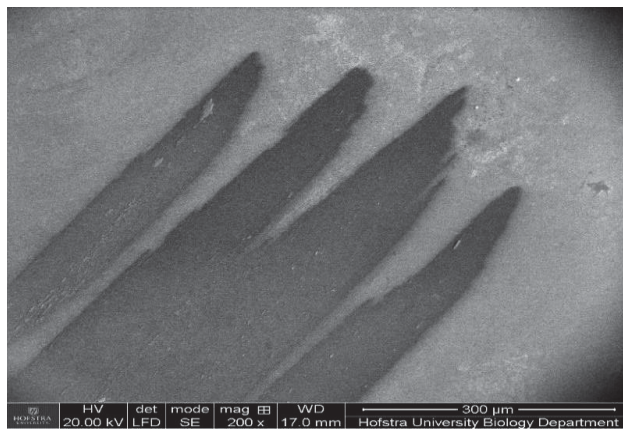
Figure 3: Scanning electron microscopic image of shallow scoring of the ceramic femoral head.

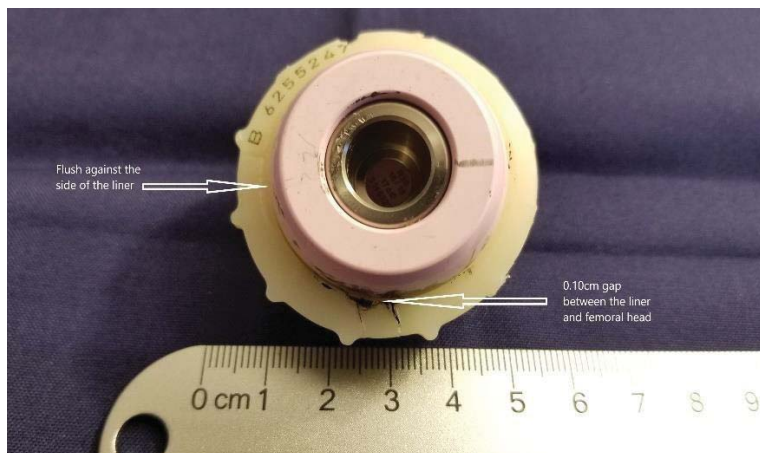
Figure 4: The ceramic head was not seating evenly within the acetabular liner. The head did not move freely within the liner. Note the approximate 0.10cm gap at the six o'clock position and the head resting flush against the liner at the nine o'clock position.

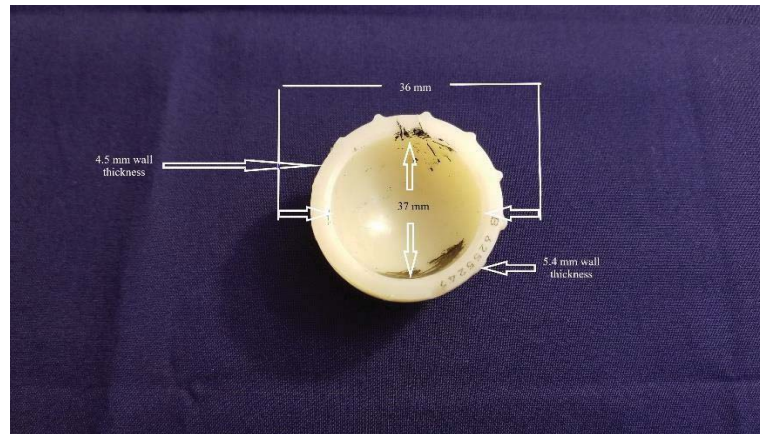
Figure 5: Diameter of the liner varied between 36mm and 37 mm. Dimensional density was measured at 4.5mm and 5.4 mm at opposite locations on the same liner.

This case illustrates that although total hip replacement dislocations can occasionally occur, that they also are not limited to any definitive cause. In this case, the cause of the dislocation would appear to be manufacturer error in the production of the polyethylene acetabular liner. The inconsistency in dimensional thickness of the walls of the liner and diameter (giving the liner an uneven, non-cylindrical shape), caused the femoral head to seat improperly impeding free rotation within the liner. When the femoral ceramic head met a certain level of resistance due to improper seating in the liner, the force caused the head to become unseated from the liner and a dislocation to occur.
